# Manhole Inspection Summary

Manhole # S41AA\_008MH

Insp Date: **11/11/08 12:10 PM**

**Location** Address: **1401 e monument st**

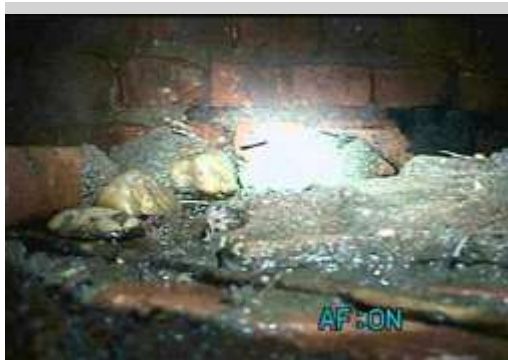
Miscellaneous

bench debris

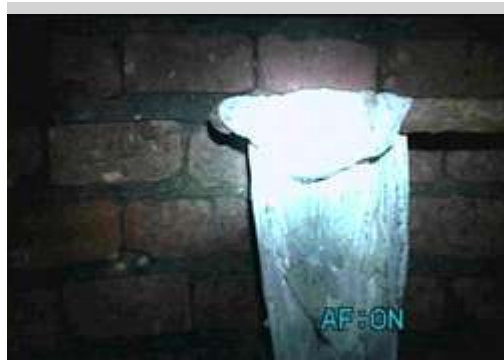
Defect 3

☒ **Evidence Of Surcharge** Depth: **6.** (ft.) ☐ Active Surcharge Present

surcharge

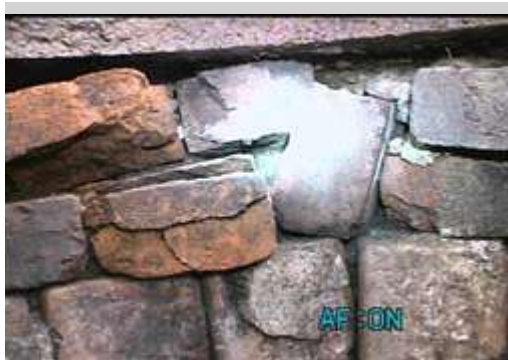
Defect 2

Condition: ☐ Sound ☒ **Cracked** ☐ Root Intrusion ☒ **Loose Brick** ☒ **Deteriorated**

frame adj

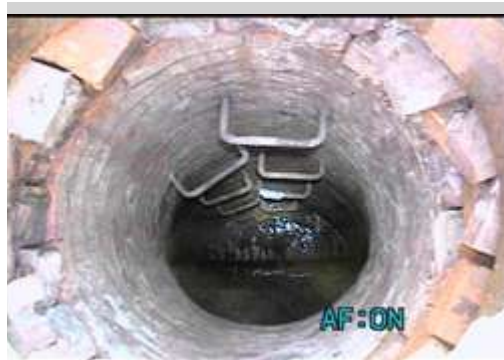
Defect 1

Count: **8** Missing: **0** ☒ **Corroded**

corr steps

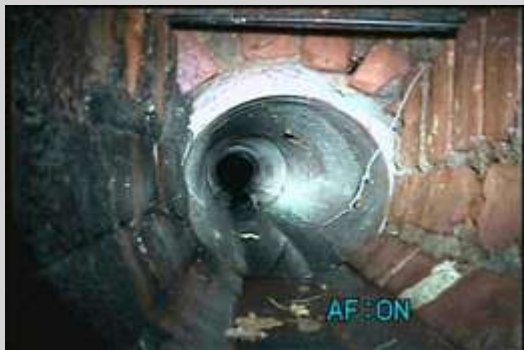
12 O'Clock Outflow

8 in. Circular Gravity Sewer  
Pipe Out @ 12 O'Clock

Invert Depth: 15.29 (ft.) Flow Characteristics: Slow

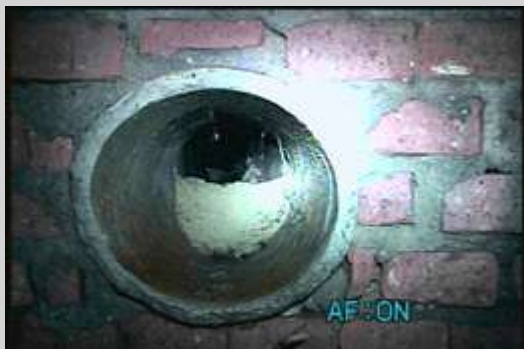
6 O'Clock Inflow

8 in. Circular Gravity Sewer  
Pipe In @ 6 O'Clock

Invert Depth: 8.92 (ft.) Flow Characteristics: Slow

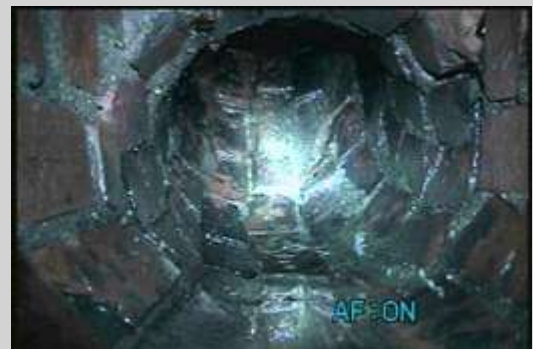
Drop In @ 6 O'Clock

brick

Drop: Outside Direct

Inv Depth: 15.13 (ft.)

Drop Condition: Open
